## Advanced Materials Methods Driving New Life in Critical Infrastructure

Fatigue damage is a major threat to many hydraulic steel structures (HSS). HSS experience fatigue loading during operation and are exposed to harsh environmental conditions that reduce fatigue life. The common methods to inspect and repair HSS is time-consuming and costly. Studies investigating the use of bonded Carbon and Basalt fiber reinforced polymer (CFRP, BFRP) to repair fatigue cracks in HSS are lacking. The main objectives of this study was to increase the bonding of FRP, investigate the effectiveness of different fiber-reinforced polymers, and perform experiments on different retrofitting configurations. In this study, eight large-scale center-cracked panels were tested under mode I loading under different environmental conditions, repair materials, and retrofitting configurations. Results indicated that the use of both CFRP and BFRP are both effective at extending fatigue life. Steel retrofitted with full patches of BFRP that cover the crack can reached infinite fatigue life. This article will conclude with several examples where FRP's have been used to repair lock gates.

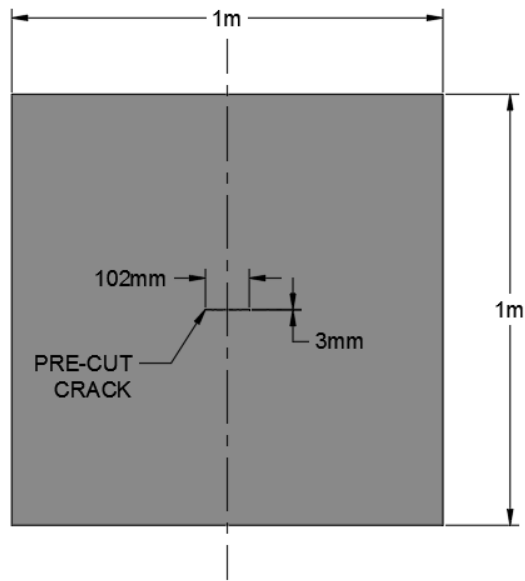
Figure 2: Dimensions of center-cracked steel plates

Constant amplitude Mode I fatigue experiments on eight unrepaired and repaired plates with dimensions of 1mx1m, a thickness of 9.5mm, and centered 102 mm precut crack (Figure 2) and different arrangements of Fiber Reinforced Polymers (FRP) were undertaken to determine the effectiveness of repairs perform with FRP. Specimens were submerged in fresh water to simulate the service environment experienced by HSS.

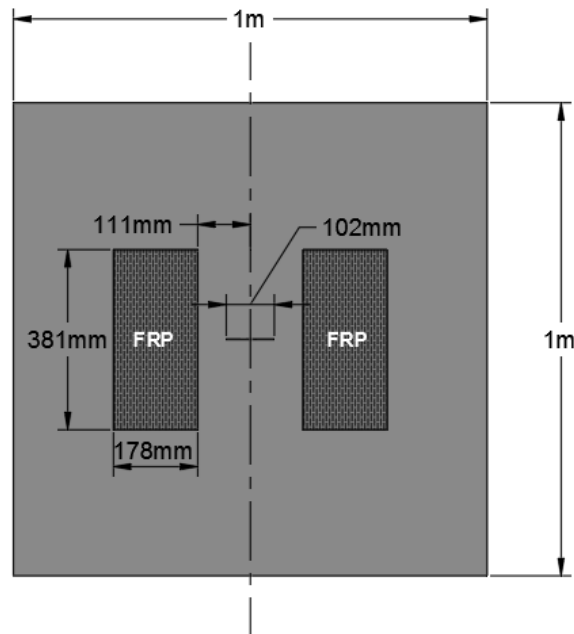
Figure 3: Dimensions of retrofitted specimens

The repaired specimens used two layers of FRP on each face. CFRP was used for specimen 3 and 5. While Basalt fibers (BFRP) was used for and specimen 4 and 6. The retrofit method and test environment for each specimen are summarized in Table 1. Figure 3 shows dimension of the retrofitted specimens.

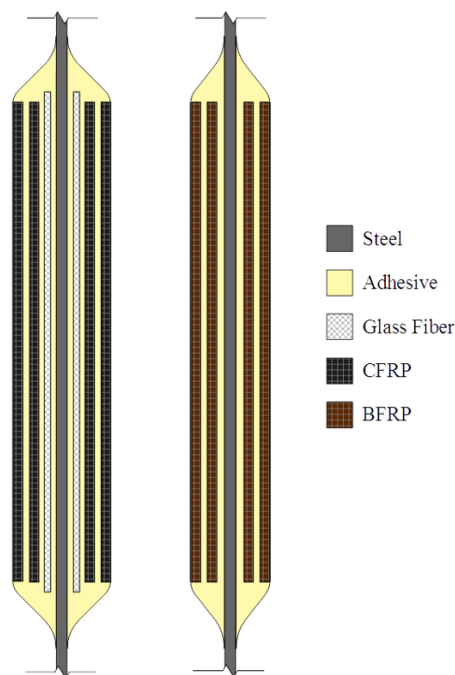
**Figure 4:** Cross-sectional view of FRP patches

An adhesive epoxy was used between the steel and FRP patch and between subsequent layers of FRP to improve bonding. A spew fillet was also formed from the adhesive around the perimeter of the FRP patch to reduce stress concentrations and prevent debonding at the patch ends. For the specimen repaired with CFRP, an additional layer of glass fiber fabric was installed between the steel and CFRP to provide an insulating barrier and prevent galvanic corrosion. Cross-sectional views of the FRP patch locations are illustrated in Figure 4.

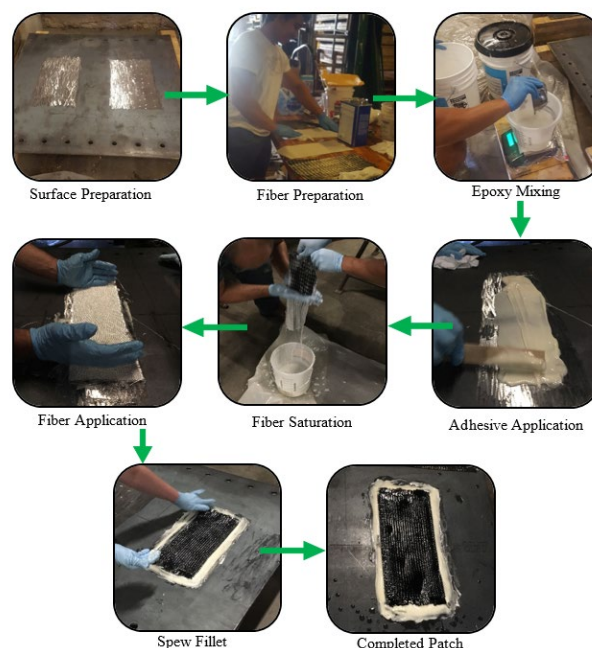
Figure 5: FRP patch retrofit application process

FRP patches were applied one at a time. Adhesive was spread on the roughened steel surface in a uniform layer using a spatula. A layer of fibers was then placed on top of the adhesive and gently pressed into the adhesive and smoothed to remove any air bubbles and align fibers. Additional alternating layers of adhesive and fibers were applied as needed for each specimen. Before being placed, carbon fibers and basalt fibers were saturated with Tyfo-S. Fibers were fully submerged in the saturant and then removed and gently stripped of excess by hand. Placement was such that the unidirectional fibers were aligned perpendicular to the crack plane. The glass fiber fabric layers were not saturated. The FRP application process is illustrated in Figure 5.

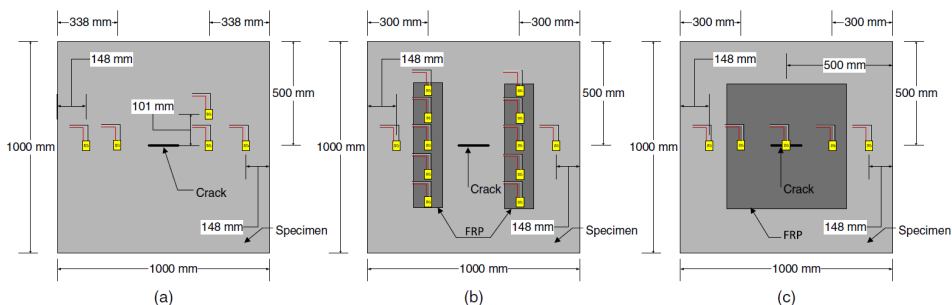
Figure 7: Strain gauge layout for: (a) specimen S1; (b) specimens S2 to S6; and (c) specimens S7 and S8.

Strain gauges were installed on each specimen as shown in Figures 7. Specimen 1 included strain gauges located above the crack plane to verify the applied nominal stress. All specimens had multiple strain gauges installed along the crack plane. Readings from these gauges were expected to increase with crack growth and grow rapidly as the crack approached a gauge. For the retrofitted specimens, additional strain gauges were used to monitor FRP debonding, if any, by placing them along the height of the patches. A drop in a reading from a gauge on the FRP indicated that the bond directly beneath it was no longer intact. Strain gauges applied to specimens 2 through 8 were covered in silicone sealant to protect them from the water. A National Instruments PXI data acquisition system was used for recording strain readings.
